Manhole Inspection Summary

Manhole # S33I__030MH

Insp Date: **11/12/08 2:30 PM**

Location Address: **w lombard st**

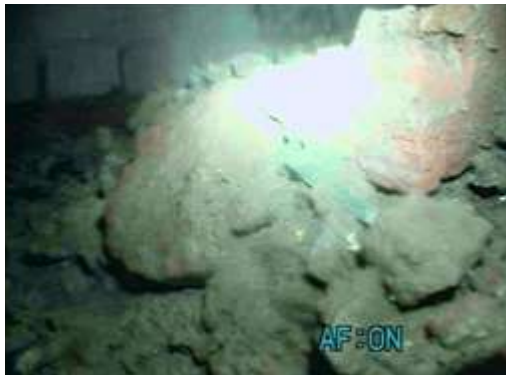
Defect 2

Condition: ☐ Sound ☐ Cracked ☐ Root Intrusion ☐ Deteriorated ☐ Leaks ☒ **Debris**

bench debris

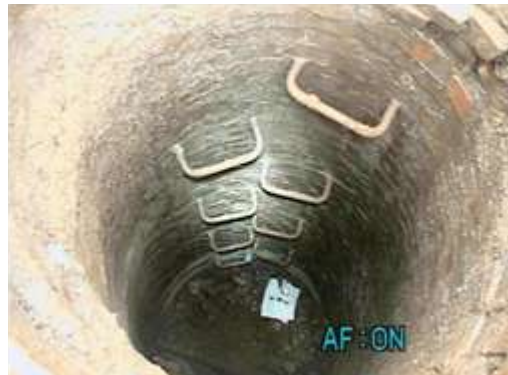
Defect 1

Condition: ☐ Sound ☐ Cracked ☐ Root Intrusion ☒ **Loose Brick** ☐ Deteriorated

Steps Count: **8** Missing: **0** ☒ **Corroded**

cor. steps and loose chimney bricks

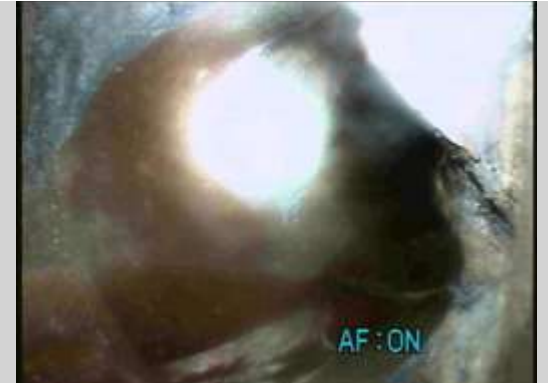
12 O'Clock Outflow

couldnt get better pic pipe is on an angle
